Safety and Accessibility Deficiencies at the Jacob K. Javits Federal Building in New York, New York

Report Number A240064/P/2/R25002 June 17, 2025

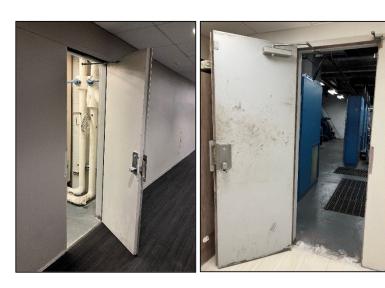
Figure 4. Examples of Elevator Machine Room Fire Doors That Did Not Self-Close 12

As shown in *Figure 4* below, we also found that two fire doors did not self-close. The self-closure mechanism on the fire door, shown in the picture on the left, functioned properly but would not self-close without physical effort because it gets caught on the carpet. The fire door, shown in the picture on the right, had defective hardware that prevented it from closing without physical effort.

Gaps in the fire-resistant walls and defective fire doors compromise the integrity of the fire barriers. As a result, fire and smoke could spread to and from the elevator machine rooms and jeopardize building occupant safety.

- 1. Take immediate actions to address any fire protection and worker safety deficiencies at the Javits Building by:
 - a. Ensuring that all fire extinguishers are mounted and unobstructed, all elevator machine rooms comply with applicable requirements for fire barriers, and all fire evacuation route diagrams are up to date to comply with fire codes.

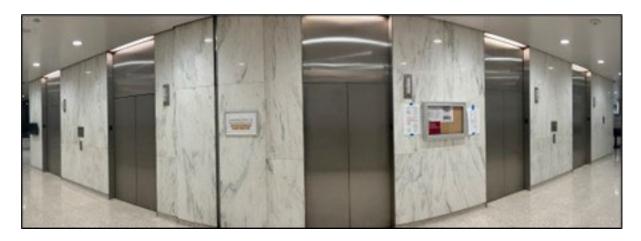
Figure 5. Elevator Lobby Without the Required Evacuation Route Diagram¹³

As shown in *Figure 5* on the next page, we found that an evacuation route diagram was missing for the elevator bank on the second floor of the Javits Building.

Clear and proper evacuation route diagrams help building occupants quickly find the nearest building exit in the event of an emergency. Therefore, PBS Region 2 should fix the deficiencies noted above and ensure that evacuation route diagrams are updated, clearly posted in the appropriate areas of the building, and legibly contain all necessary and critical building evacuation information.

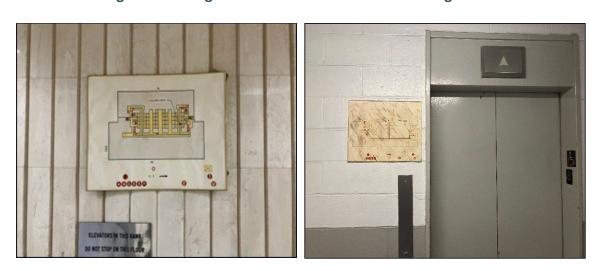
Figure 6. Damaged and Worn Evacuation Route Diagrams¹⁴

Figure 6 below shows two building evacuation route diagrams (on the sixth floor [left photo] and in the basement [right photo]) in the Javits Building. Both diagrams are old, visibly damaged, and worn. These diagrams are also missing critical information, such as street names and floor numbers.

The sixth floor of the Javits Building is a high-traffic area because it contains public restrooms. Visitors frequent this floor, and if they are in this elevator bank during an emergency, the incomplete diagram could hinder their ability to safely find the nearest evacuation route.

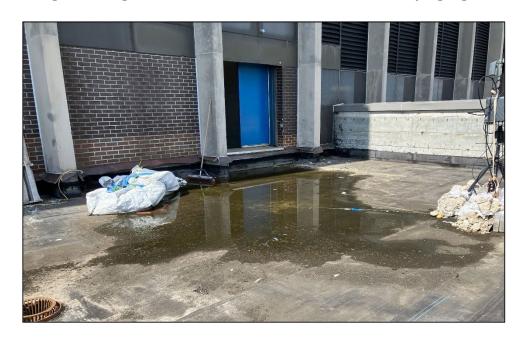
Figure 8. Large Puddle on the Roof with No Precautionary Signage¹⁸

Additionally, we observed a large puddle on the roof of the Javits Building from a recent rain that created a slipping hazard. *Figure 8* below shows a large puddle while the rest of the roof is dry. This suggests that standing water persists in this area for an extended period after a rain event; however, the required signage to warn workers of the slipping hazard is not present.

PBS Region 2 and the O&M contractor should have taken precautionary actions, such as posting caution signs, to warn workers of the slipping hazards in accordance with applicable policies and regulations.

- b. Confirming that the O&M contractor promptly repairs water leaks or displays proper signage in affected areas to prevent slipping accidents in accordance with OSHA requirements. This is especially important for prolonged leaks for which PBS Region 2 is awaiting repair funding.
